PHASE I ENVIRONMENTAL SITE ASSESSMENT

ST. PAUL SCHOOL ST. PAUL ISLAND, ALASKA

Tetra Tech EM Inc.
6100 219th Street SW, Suite 550
Mountlake Terrace, Washington 98043

August 24, 2004

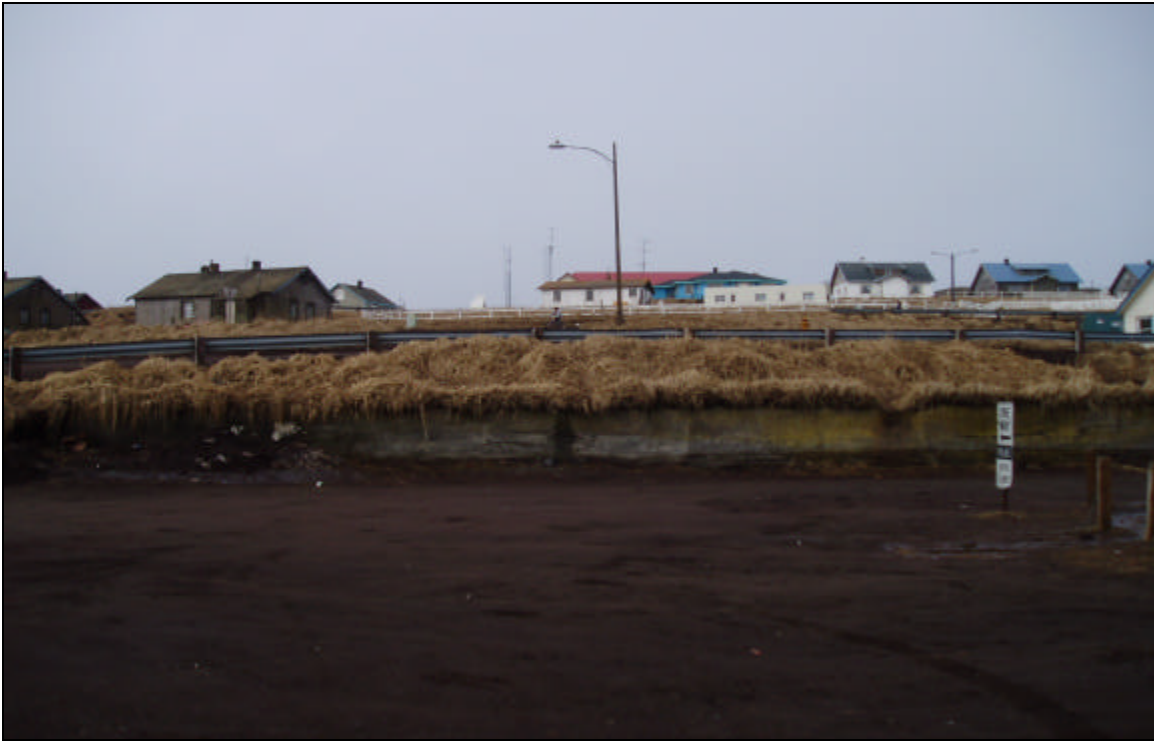
Photograph No. 3
 Orientation: West
 Description: Looking west from the subject property.

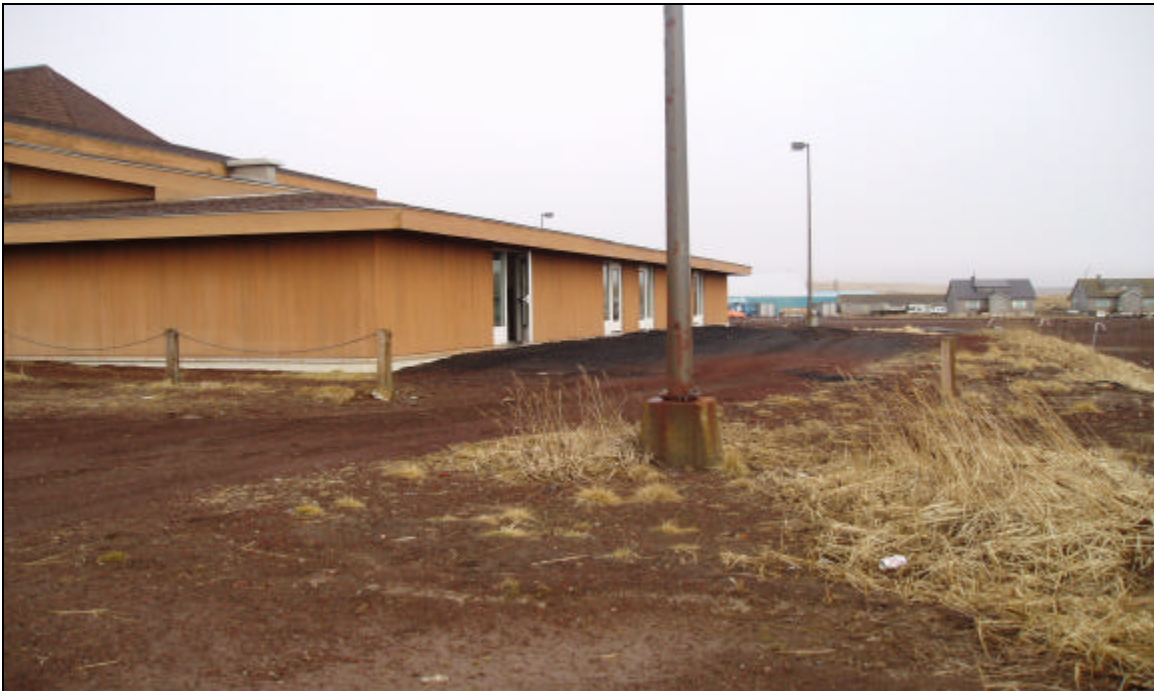
Photograph No. 4
 Orientation: North
 Description: Looking north at the subject property. The school is visible in the foreground, and the A/C Value Center general store is located in the distance.

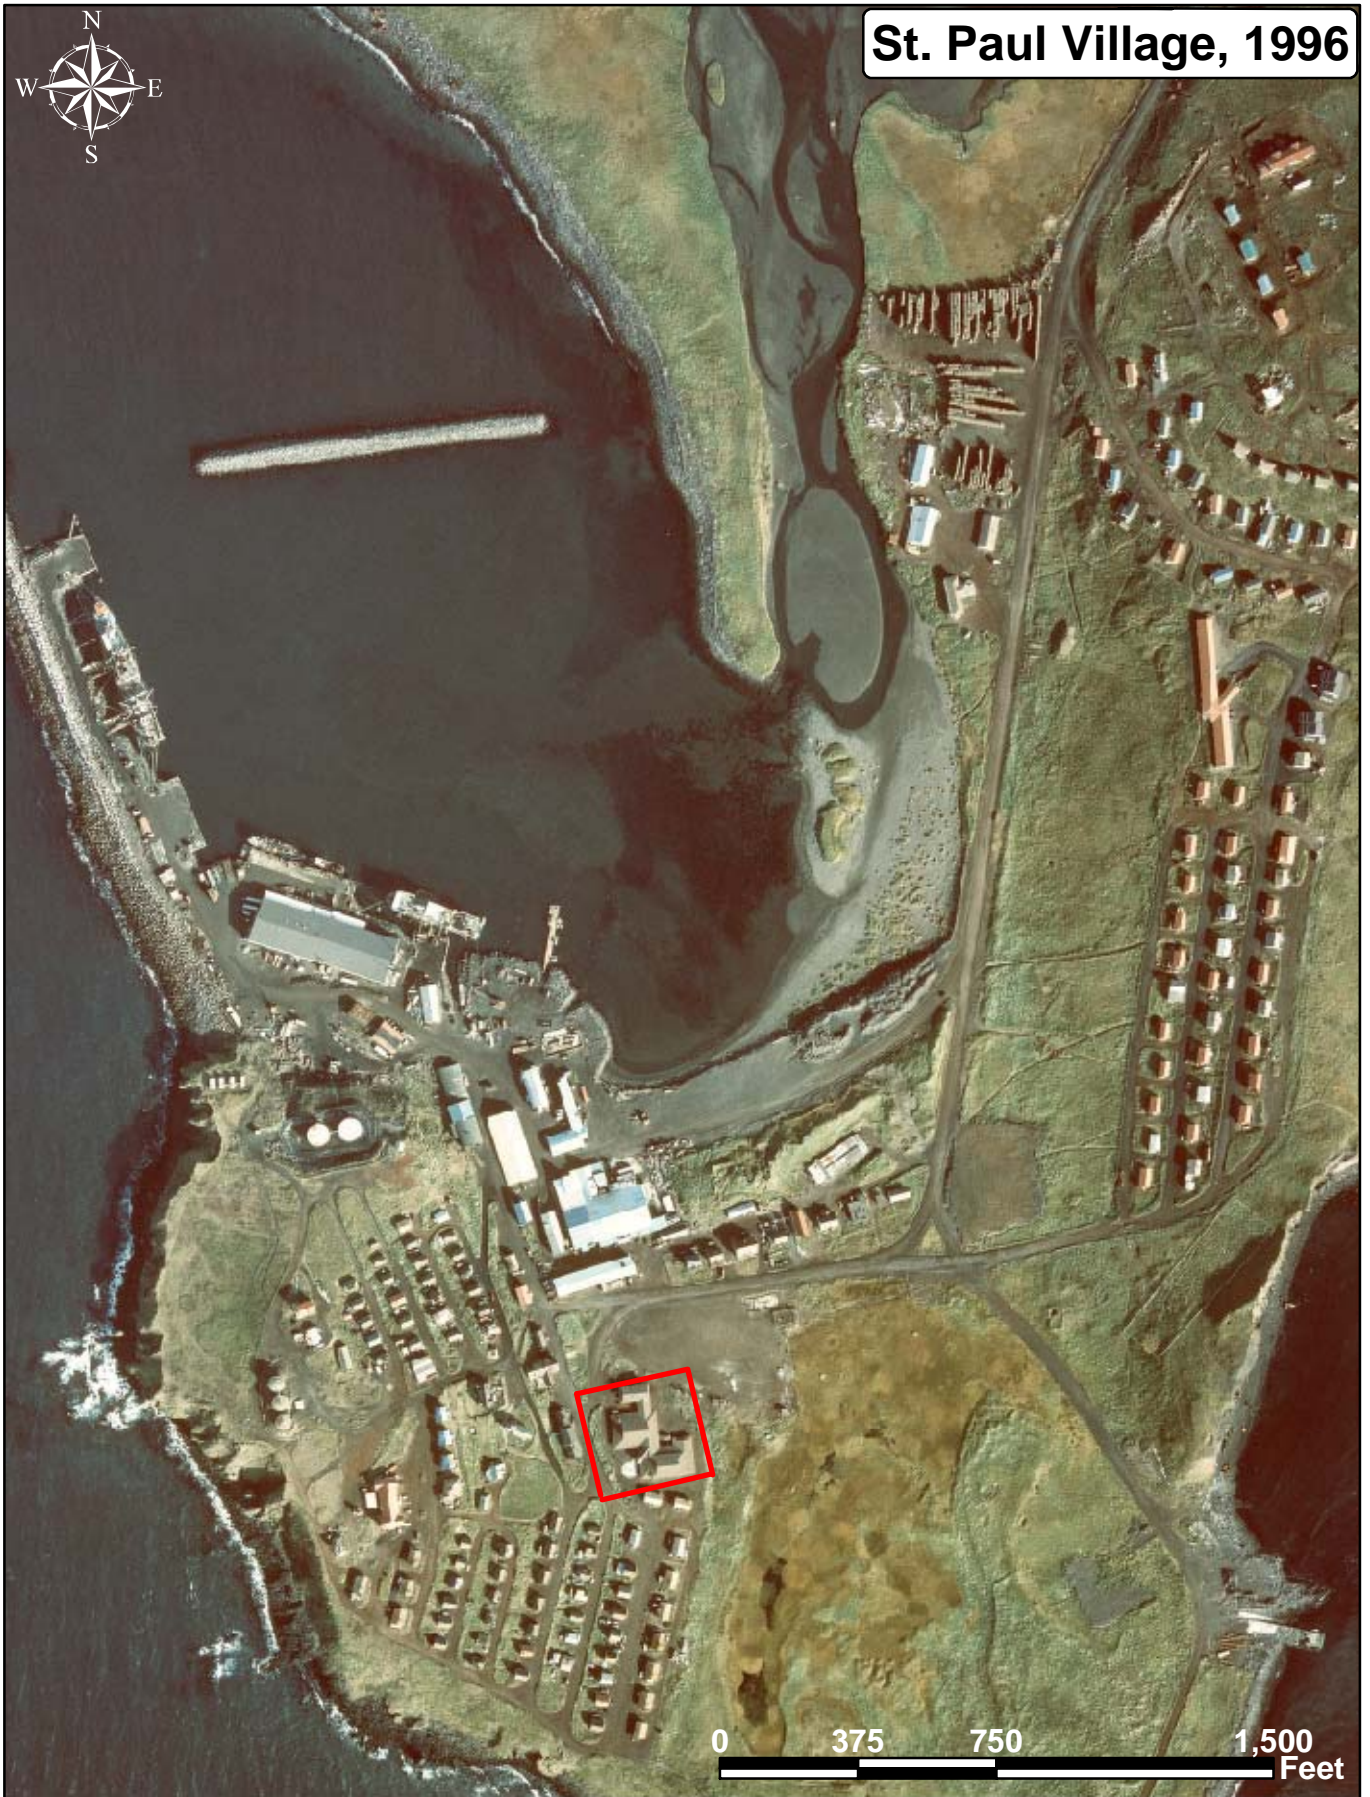
St. Paul Village, 1996

- **1996.** This photograph shows the school building currently located at the subject property. Other properties within the vicinity of the subject property are generally shown as exhibiting current conditions.
- **1982.** This photograph shows the school building currently located at the subject property. Two small structures of unknown use are visible on the adjacent property to the east. Other

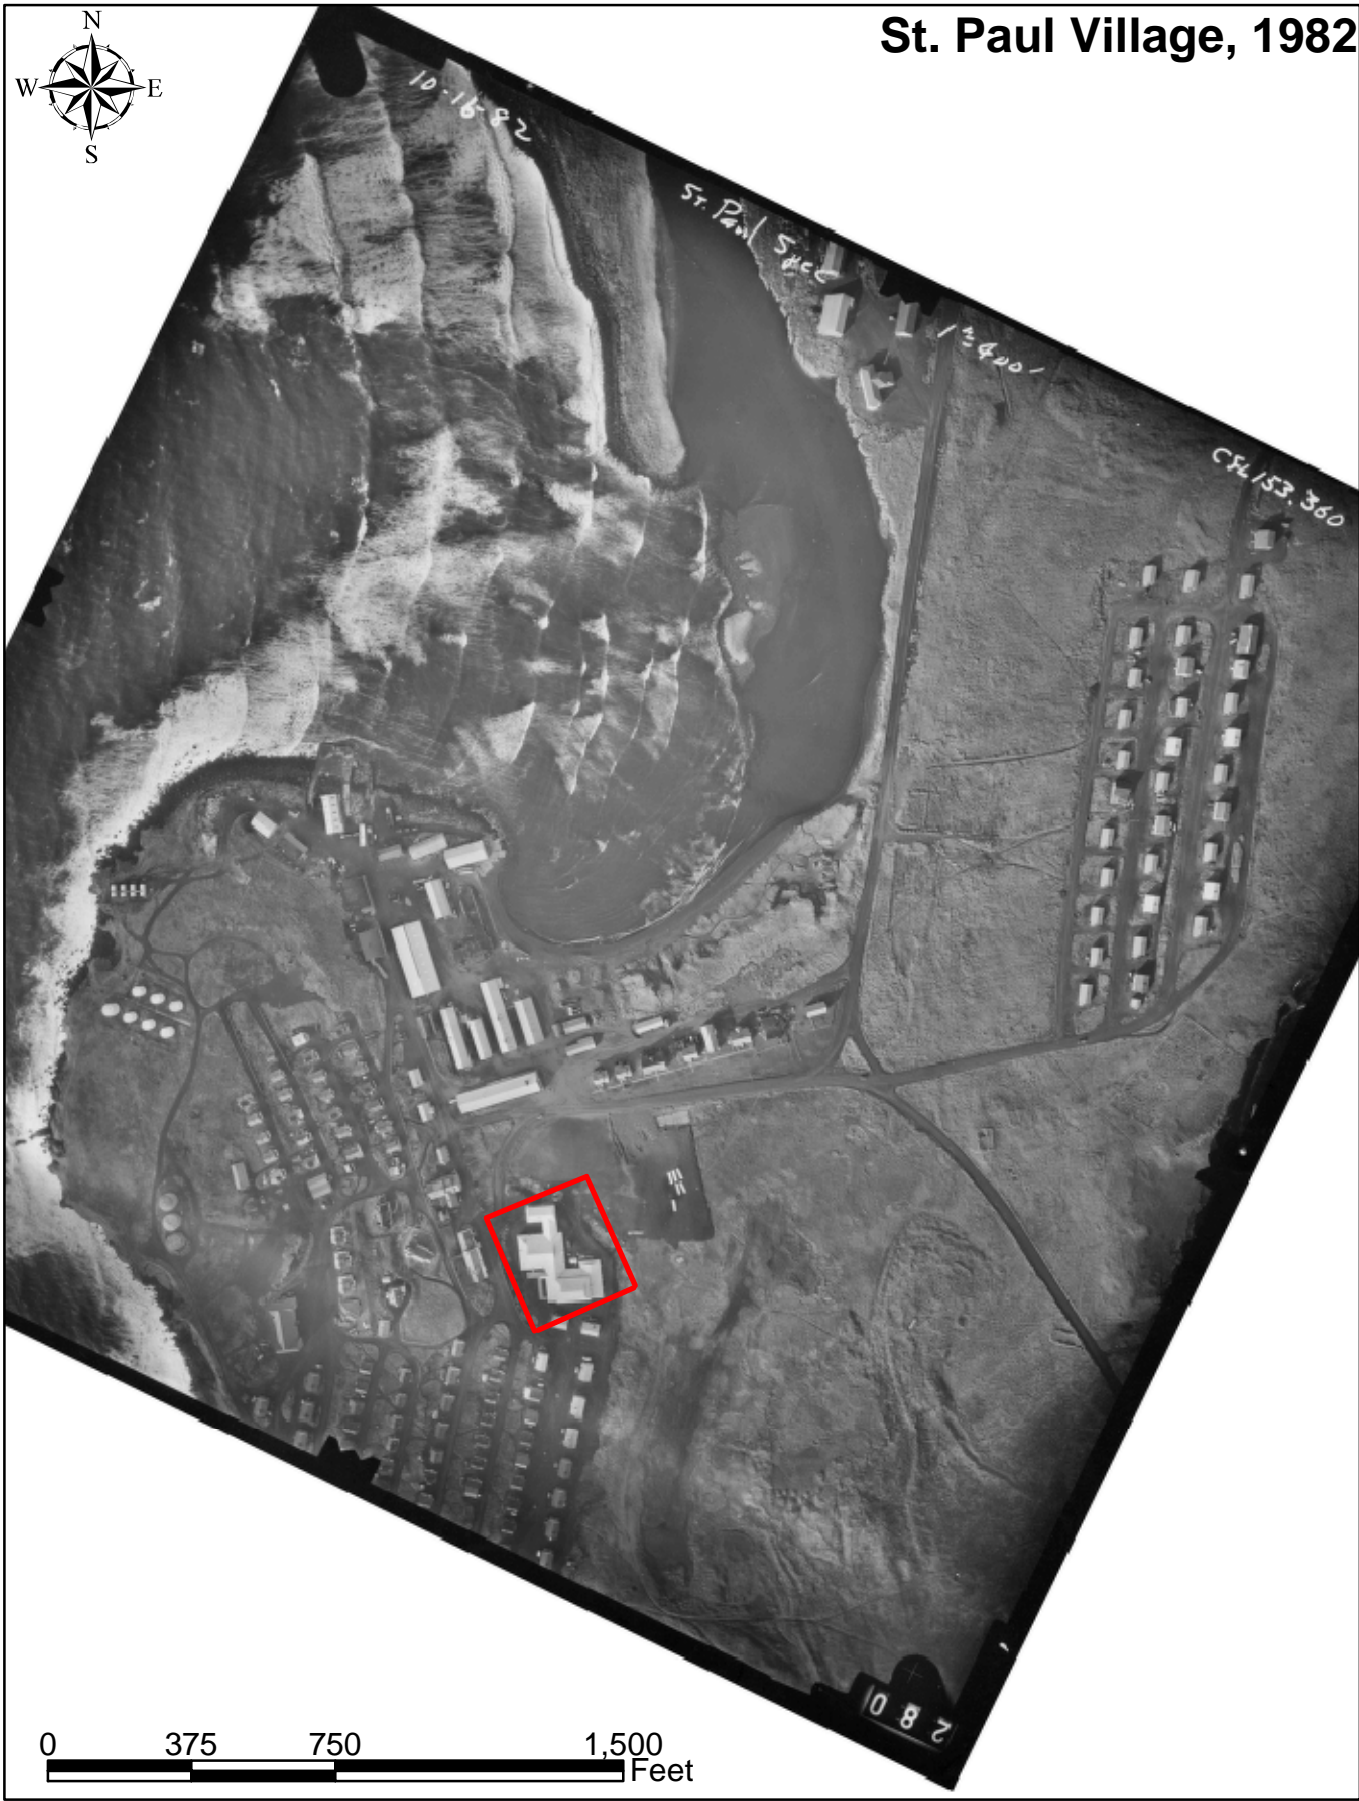
St. Paul Village, 1982

properties within the vicinity of the subject property are generally shown as exhibiting current conditions.

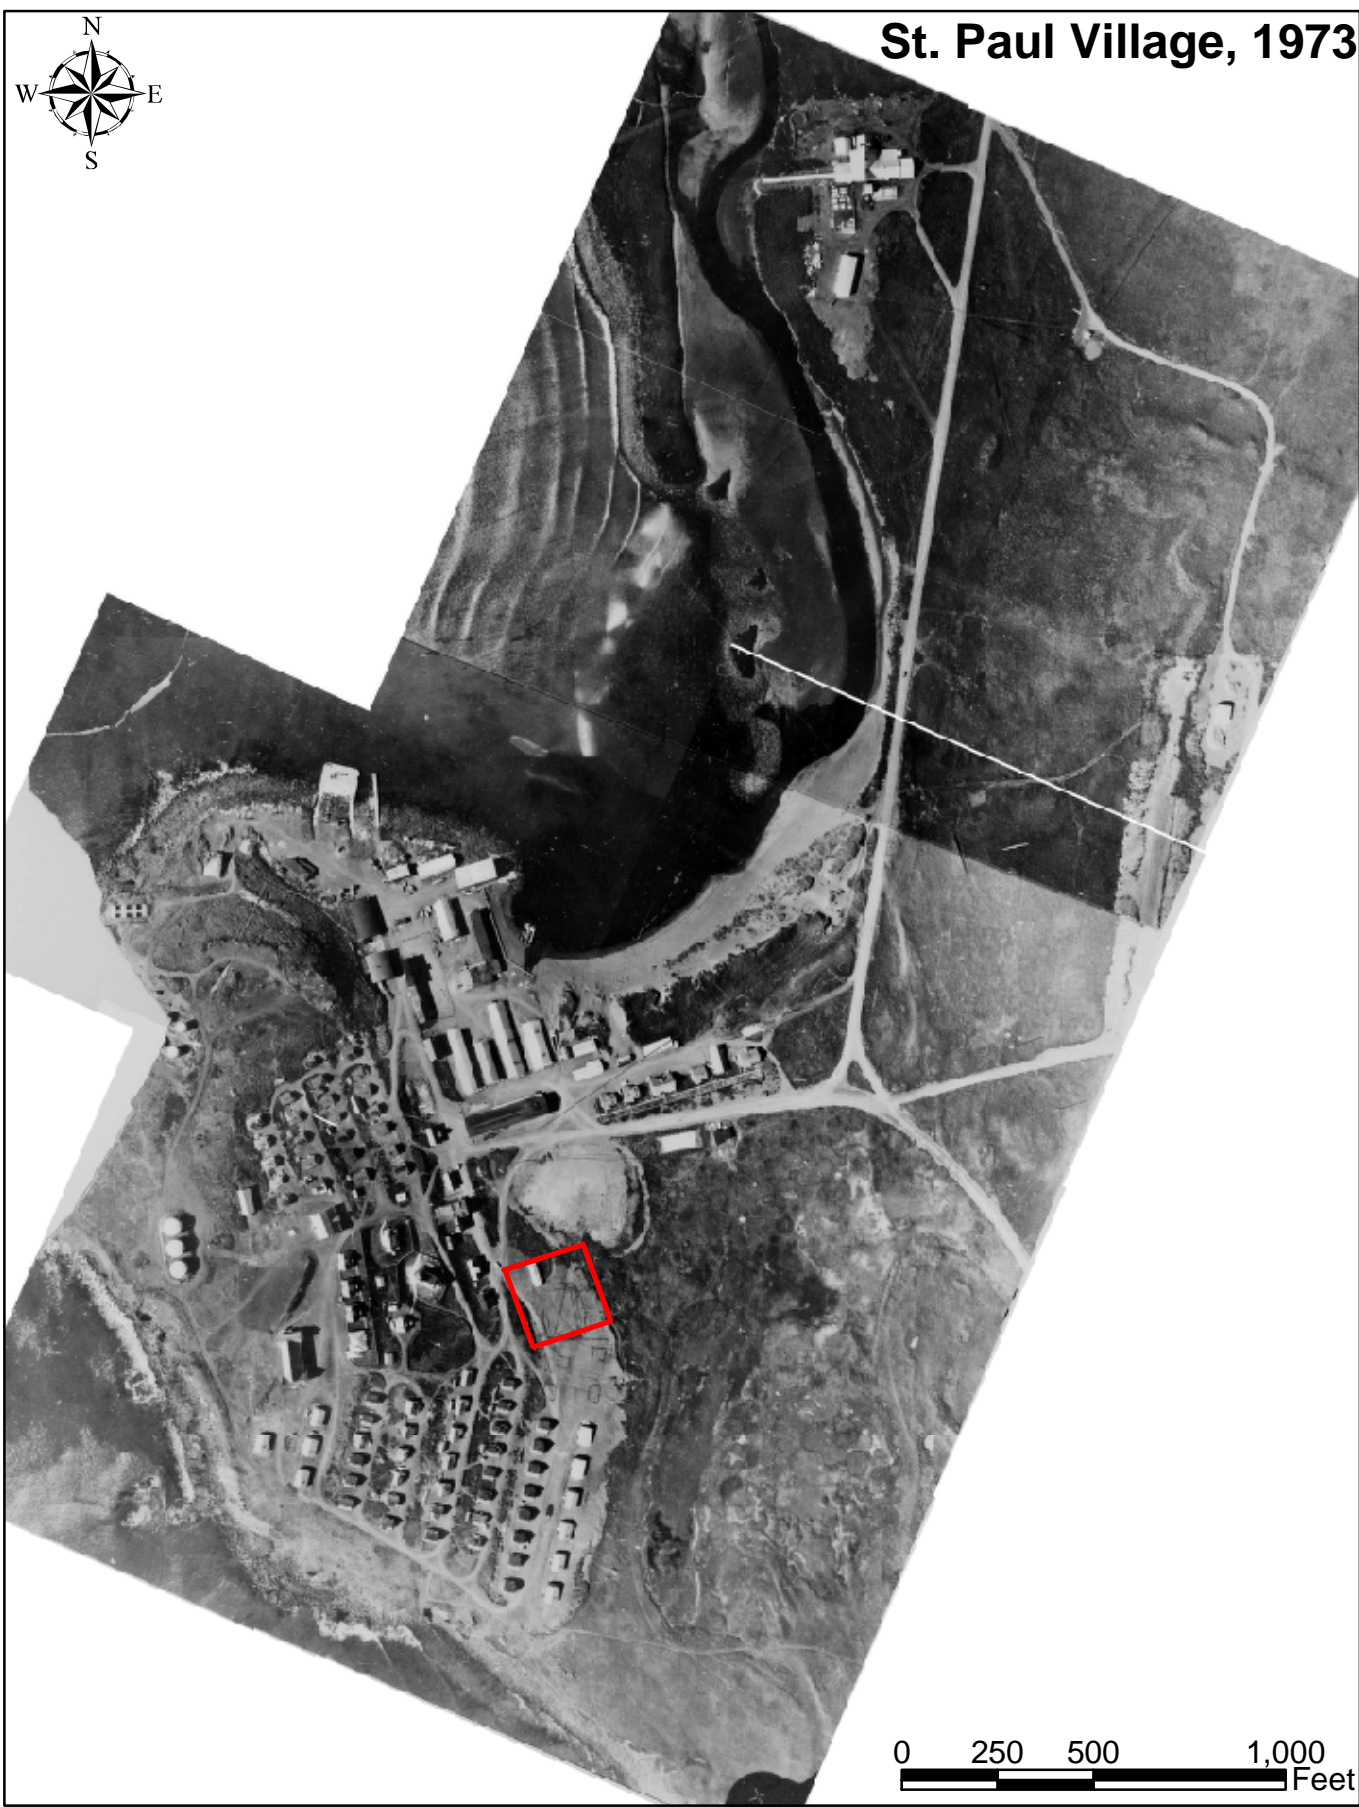
St. Paul Village, 1973

- **1973.** From this photograph, it appears that the school is still under construction at the subject property. Surrounding property to the south and east is undeveloped. Other properties within the vicinity of the subject property are generally shown as exhibiting current conditions.
- **1967.** From this photograph, it appears that the Butler Building has been demolished, but construction on the school has not yet begun. Surrounding property to the south and east is undeveloped. Other properties within the vicinity of the subject property are generally shown as exhibiting current conditions.
- **1948.** The photograph shows the Butler Building and a second building in existence at the subject property. The nature of the second building could not be determined through exhaustive interviews with village elders and others knowledgeable about St. Paul history.
